Amarillo Chamber of Commerce – aka Bivins Bldg.
1000 South Polk Street

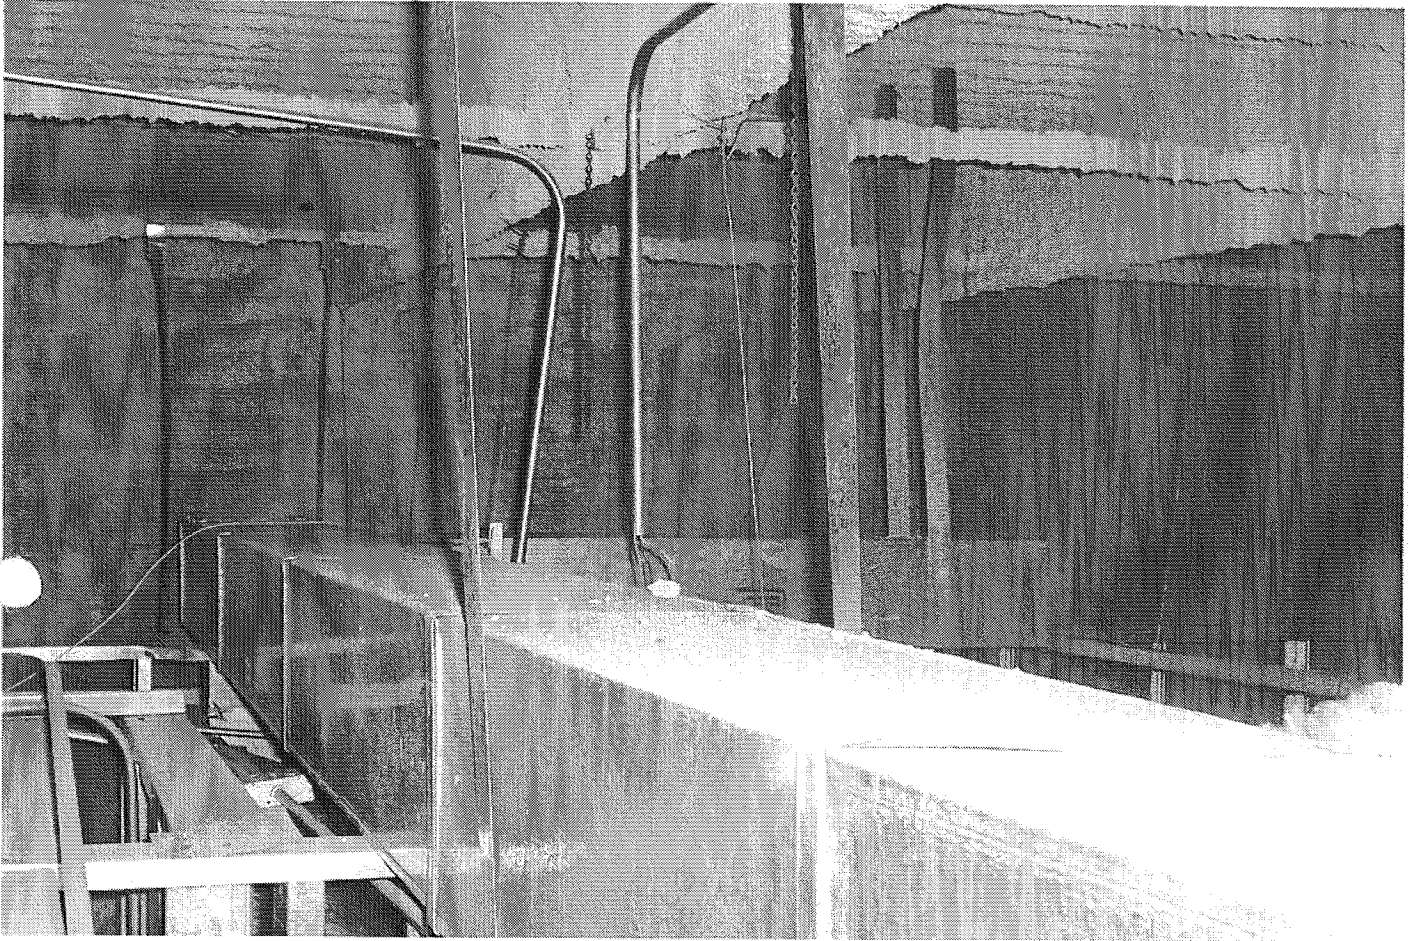
27. Main Terminal, 3rd floor, Mens Rest Room - View of delaminated fireproofing dust and debris on top of metal HVAC duct

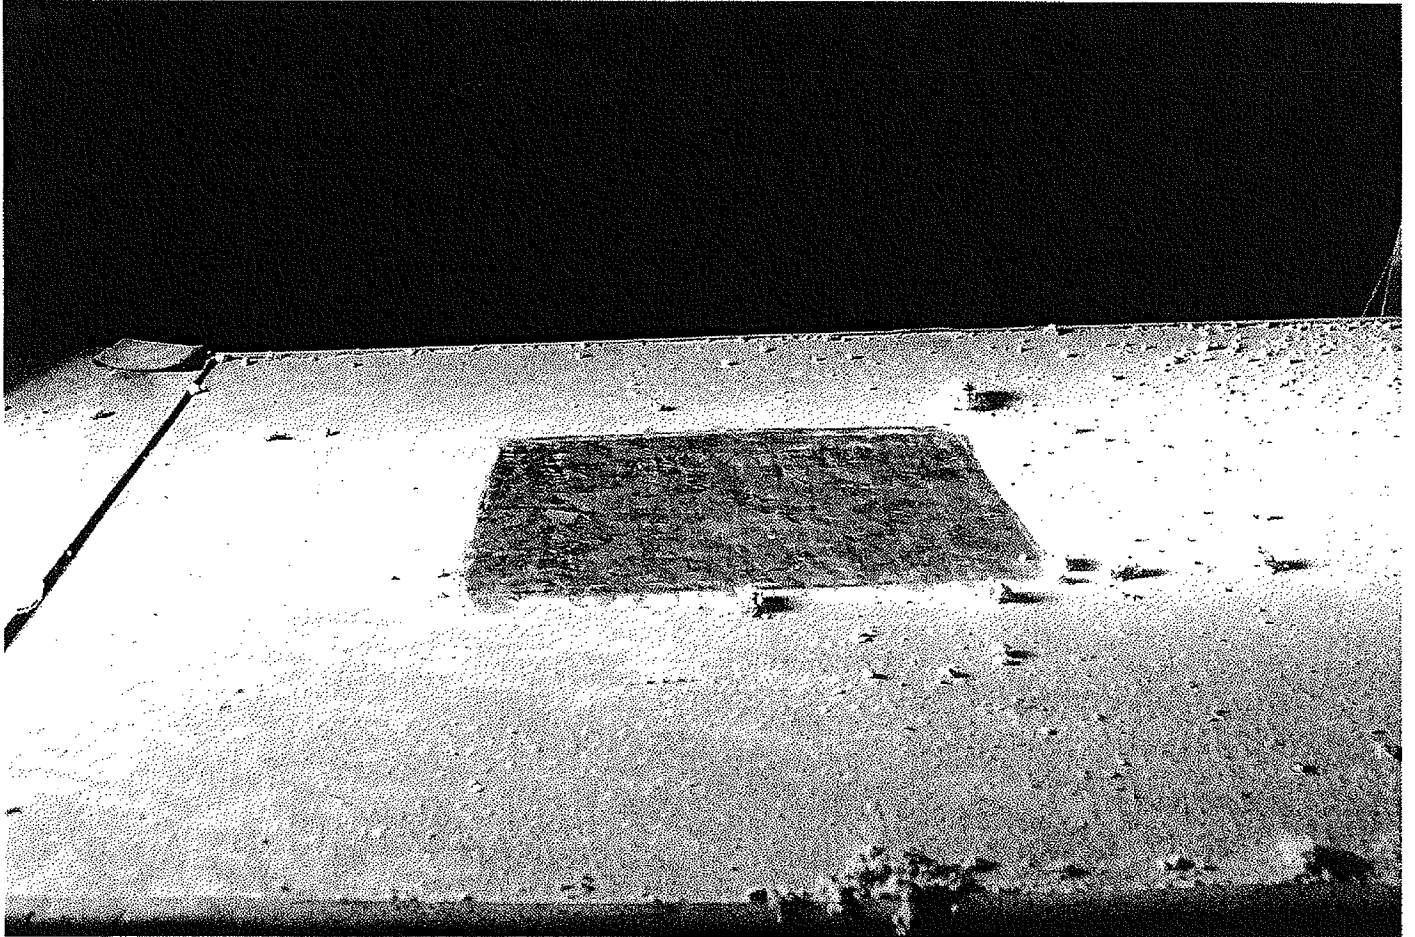
28. Main Terminal, 3rd floor, Mens Rest Room - Close-up of dust sample #6 location (top of HVAC duct)

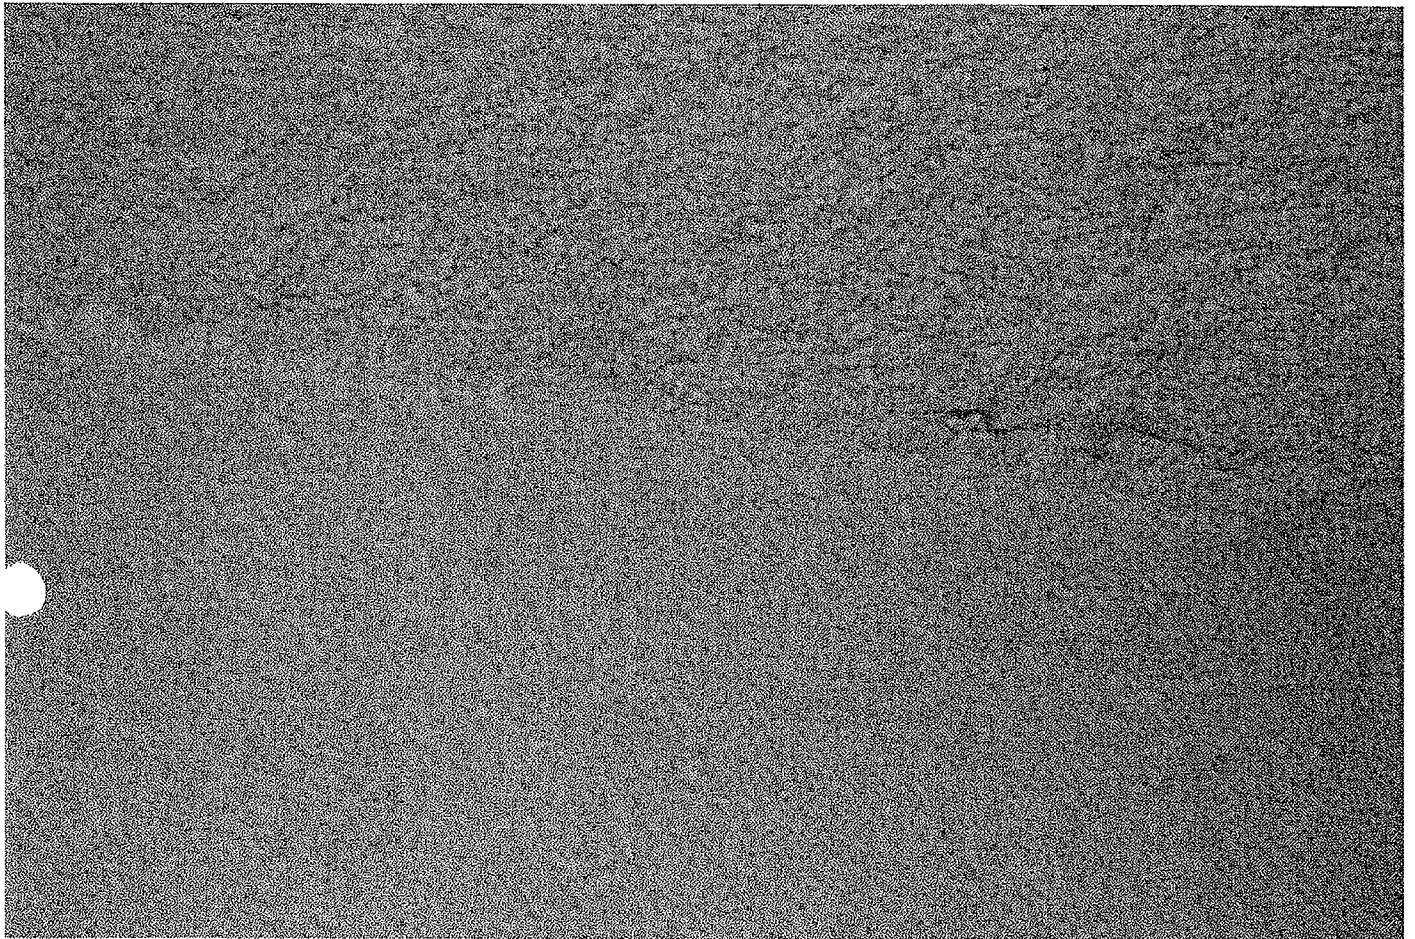
1. Basement, back hallway at janitors storage area - General view of damaged acoustical plaster
